Failure of rammed earth walls: from observations to quantifications

Tan Trung Bui, Quoc-Bao Bui, Ali Limam, Sandrine Maximilien

Tan Trung Bui, Quoc-Bao Bui, Ali Limam, Sandrine Maximilien. Failure of rammed earth walls: from observations to quantifications. *Construction and Building Materials*, 2014, pp.295-302. hal-00918221

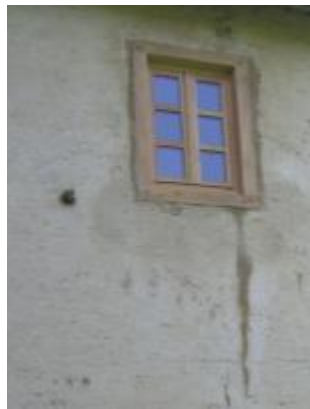
70
 71 **Figure 1: Typical failure of an old rammed earth wall in France.**

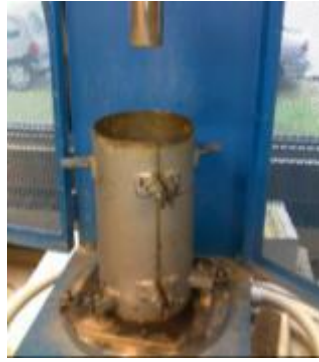
91 The automatic Proctor machine was adopted (Figure 2). The standard mold of the Proctor test was replaced
92 by a mold 16 cm in diameter and 32 cm high. To obtain the dry density of *in-situ* rammed earth material
93 ($\sim 1920 \text{ kg/m}^3$; Bui *et al.* 2009b), a series of preliminary tests were conducted to determine the manufacturing
94 water content and the amount of soil to be poured into the mold for each layer. An 11% moisture content was
95 chosen as the compaction moisture content and 2.2 kg of moist soil was weighed out for each layer. Each
96 layer received the Proctor energy ($E = 0.6 \text{ kJ/dm}^3$). There were six compaction layers in each specimen
97 prepared. The final height of the cylinder after the release was about 30 cm. Prior to mixing, the soil was
98 sieved through a 2-cm screen.

Figure 2: Automatic Proctor machine and modified mold.

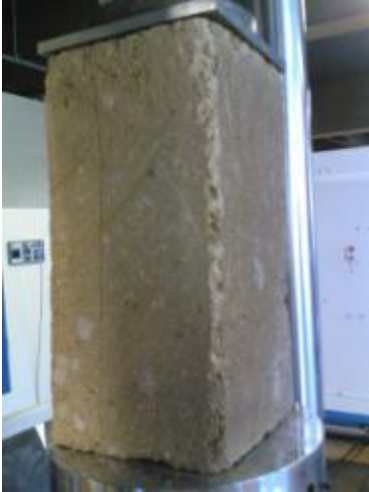
The compression tests in the parallel direction of the layers were *a priori* done a nonhomogenous material (Fig. 4a). Firstly, the stress was not uniform in the specimen during the test due to the heterogeneity of the dry density within a layer (which increased from the bottom to the up of layer). So the stress was discontinuous from one layer to another. Therefore, the determined stress was an average value (the load applied by the press divided by the section of the specimen). Secondly, layer separation occurred fairly early during the test, notably the first crack in the last layer, meaning that the specimen was no longer a continuous medium. However, these separations did not seem to significantly alter the specimen's mechanical capacities, since each layer continued to support the load alone. There was no change in slope even after the abrupt loss of adhesion due to the separation (Fig. 4b). During the test, the first crack appeared fairly early, due to the separation of the last manufacturing layer (Fig. 4a). This phenomenon has already been discussed in Bui and Morel (2009). The complete failure of the specimen occurred when the third vertical crack appeared. It corresponded to the maximum extension of the material (the strain corresponds to the maximal stress) and to the internal failure within a layer leading to the failure of the entire specimen. The results will be discussed in section 3.3.2 and will be used to identify tensile strength at the interfaces between layers.

179 **Figure 4: Uniaxial compression test in the direction parallel to the layers**

182 Since RE is a superposition of earth layers, it is necessary to distinguish two tensile strengths: the tensile
183 strength in earth layers and the tensile strength at the interfaces of earth layers (Fig. 4a).

213 Following the results of tests in the direction parallel to layers, separation of the second layer was about 50%
214 of the compressive strength in this direction ($\sigma_{zz, \text{separation}} \cong 0.5 \sigma_{zz, \text{max}}$; Fig. 4b). The Poisson's ratio measured
215 was 0.22 (more information can be found in Bui *et al.* 2013).

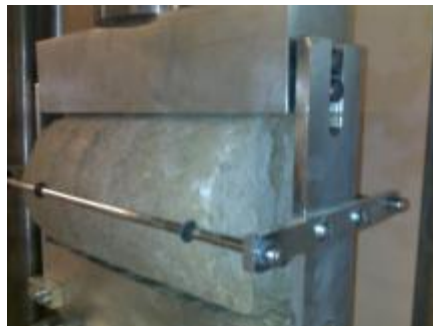
188 To determinate the tensile strength within earth layers, the Brazilian test was used (Fig. 5). The synthesis of
189 the results is illustrated in Fig. 6.

Figure 5 Brazilian test to determine the tensile strength

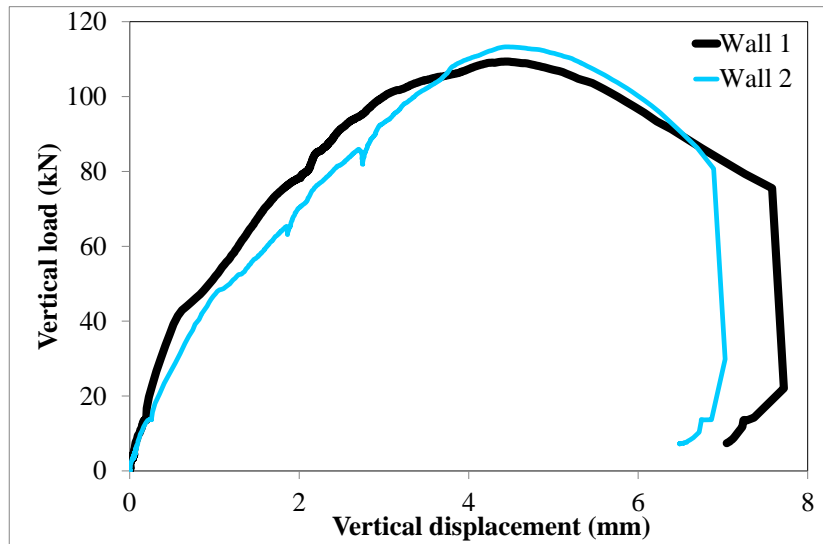
Figure 8 presents the load–displacement relationships obtained for two wallettes. These two curves are similar, which shows a repeatability of results. The behavior was quasi-linear up to 42 and 45 kN, respectively, for the first and second wallettes. Then a decrease in the slope was observed, corresponding to the appearance of the first cracks in the wallettes. The mean failure load of the two wallettes reached 112 kN, which corresponds to a vertical displacement about 4.5 mm from the wallette's central point. The third phase was a post-peak behavior, which presents a substantial drop in the slope.

Figure 8: Load–displacement relationship of two wallettes.

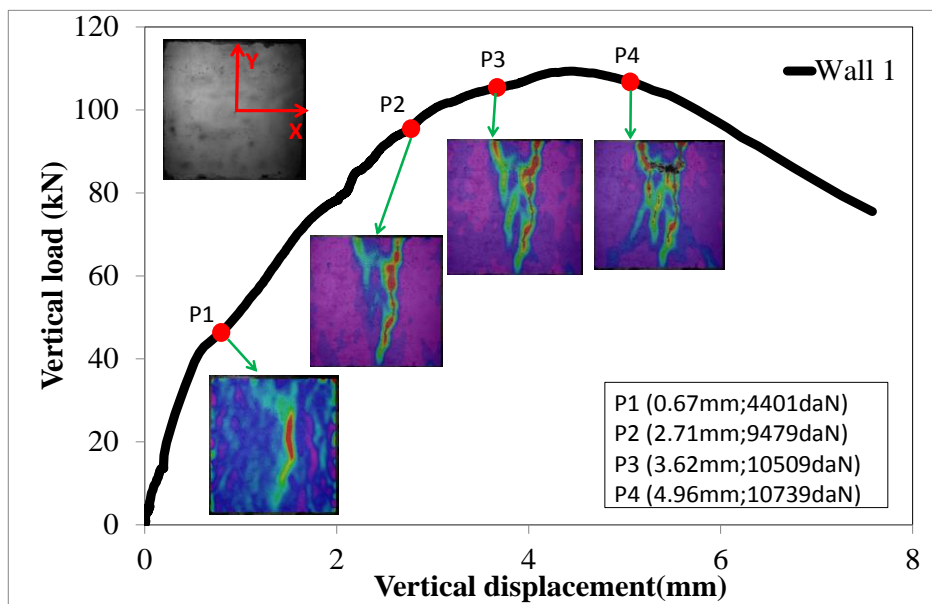
266 Monitoring the crack propagation was recorded by the image correlation. Synchronization between the
 267 stereovision system and the load and displacement sensors identified the behavior of the wallettes and crack
 268 appearance (Figure 9). The cracks were identified by observing the horizontal strains ϵ_{xx} of the wallette face.
 269 At the beginning of the second phase (post-elastic phase, point P1 on Figure 9), a vertical crack was
 270 observed. Then this vertical crack continued to develop and other vertical cracks appeared in the central part
 271 (points P2 and P3 in Figure 9). When the post-peak phase began (point P4 in Figure 9), inclined cracks
 272 appeared, which propagated to two corners of the wallette. These inclined cracks seem to have been
 273 influenced by the friction between the wallette and the metallic base.

Figure 9: Crack development on wallette 1.

277 Two types of cracking were observed: vertical cracks which appeared in the central part and inclined cracks
278 at the corners. These cracks crossed the compacted earth layers, and there was no crack bifurcation at the
279 layer interfaces. This means that the cracks were not influenced by the layer's superposition, so the
280 hypothesis of a homogeneous material was acceptable in this case.

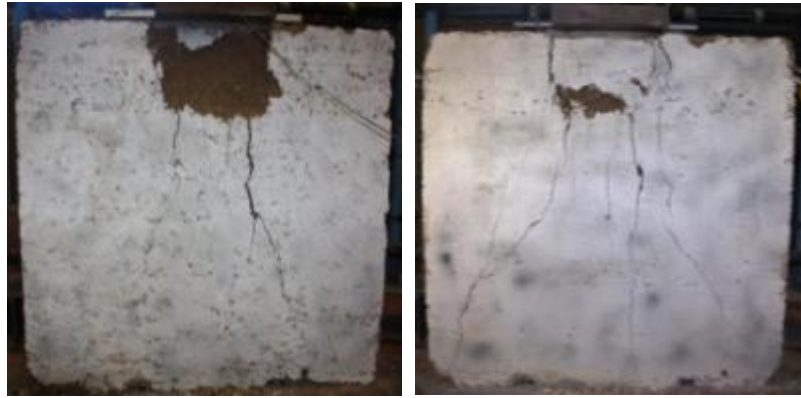
Figure 10: Failure modes of the wallettes: (a) Wallette 1; (b) Wallette 2.

288 Figure 10). A fracture surface developed between the loaded zone and the neighbor unloaded zone because
289 of a differential settlement (Figure 11). This fracture surface was quasi-vertical and so different from those in
290 reinforced concrete structures where the fracture was about 45° from the horizontal plane. In concrete
291 constructions, several empirical formulas are proposed to determine the shear strength (Eurocode 2), which
292 is a function of the compressive strength. For RE material, to study the behavior of a concentrated load, shear
293 strength must also be determined.
