Probing impact on pad moisture tightness: A challenge for pad size reduction

Matthias Vidal-Dhôte, Quentin Hubert, Patrice Gonon, Philippe Delorme, Jonathan Jacquot, et al.. Probing impact on pad moisture tightness: A challenge for pad size reduction. Conference on Microelectronic Test Structures (ICMTS), 2019, Kita-Kyushu, Japan. pp.176-179, 10.1109/ICMTS.2019.8730990 . hal-02362746

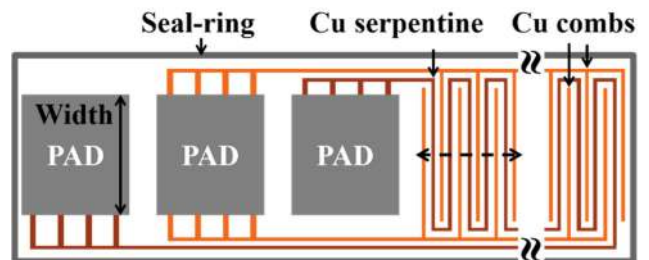
Figure 3.a: Elementary studied structure composed of a metal serpentine running between two interwoven metal combs and surrounded by a seal-ring.

The elementary studied structure is composed of a metal serpentine running between two interwoven metal combs each one being connected to a dedicated pad used for biasing and sensing (Figure 3.a). This structure is replicated in the 3 metal layers connected to independent pads allowing to test each level independently (Figure 3.b). To ensure that pollutants and moisture will not contaminate the structure from the side, it is fully enclosed by a seal-ring [2]. Table I indicates drawn metal spacing, width and serpentine length. Devices with pad width varying from 30 μm to 130 μm with a step of 20 μm have been designed. To remain compatible with 90nm probing equipment, pads spacing and height are kept to 60 μm and 70 μm , respectively.

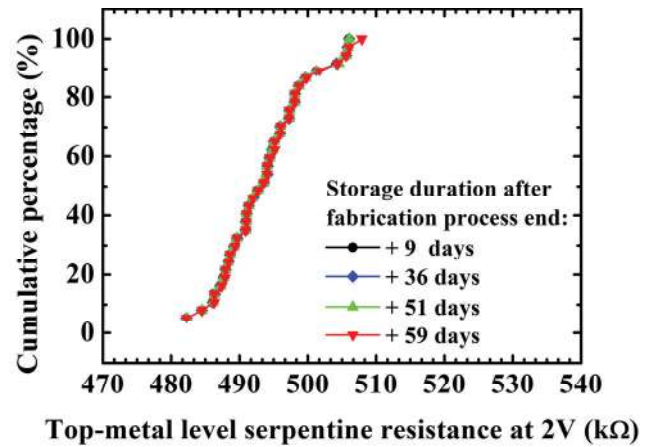
Figure 6: Top-metal level serpentine resistance at 2 V of the structure with 30 μm -wide pads measured after 9, 36, 51 and 59 days of storage at room condition after fabrication process end. Similar results are obtained on the two other metal levels.
