Probing impact on pad moisture tightness: A challenge for pad size reduction

Matthias Vidal-Dhôte, Quentin Hubert, Patrice Gonon, Philippe Delorme, Jonathan Jacquot, et al.. Probing impact on pad moisture tightness: A challenge for pad size reduction. Conference on Microelectronic Test Structures (ICMTS), 2019, Kita-Kyushu, Japan. pp.176-179, 10.1109/ICMTS.2019.8730990 . hal-02362746

Probing impact on pad moisture tightness: a challenge for pad size reduction

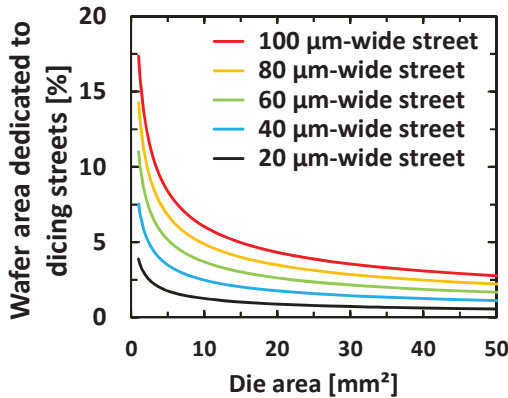
Figure 1: Percentage of wafer area dedicated to dicing streets as a function of die area. Percentages are calculated assuming a square die and same street width on X and Y. When the die is not a square, the percentage of wafer area dedicated to dicing streets might be slightly different.

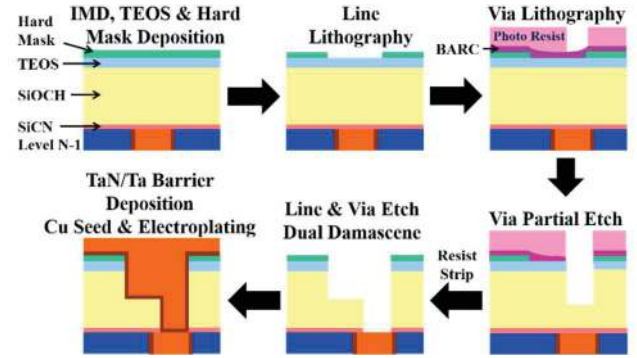
Figure 2: Process flow used to fabricate one metal layer. To create successive metal layers, this sequence is repeated

In many applications such as automotive and medical, chips must be highly reliable and thus, pass challenging quality assessments including Wafer-Level Reliability evaluation, exhaustive Parametric Test and extended Electrical Wafer Sort. To fulfill such demanding requirements, a large number of test structures – placed in wafer dicing streets – are needed. However, the smaller the die, the higher the wafer area dedicated to dicing streets (Figure 1). Therefore, a way to reduce the dicing streets area is to reduce the street width. To this extent, structures with narrower pads are mandatory. Probing equipment having a limited precision, hitting small pads in reduced street width might provoke non-previously existing reliability issues in test structures. In this paper, the impact of probing on narrow pads integrity of specifically designed test structures is evaluated with dedicated test methods. These test structures are embedded in an automotive-qualified 90nm-node of a 200mm process line with 3 dual-damascene copper-levels Back-End-Of-Line (BEOL) with SiCOH low- κ intermetallic dielectric (IMD), 45 nm-thick SiCN capping layer and Ta/TaN diffusion barrier [1]. Figure 2 describes the process flow of one metal layer.

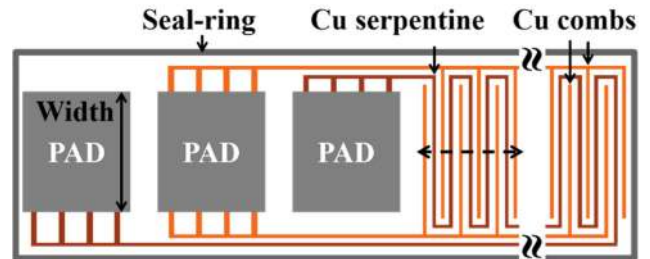
Figure 3.a: Elementary studied structure composed of a metal serpentine running between two interwoven metal combs and surrounded by a seal-ring.

The elementary studied structure is composed of a metal serpentine running between two interwoven metal combs each one being connected to a dedicated pad used for biasing and sensing (Figure 3.a). This structure is replicated in the 3 metal layers connected to independent pads allowing to test each level independently (Figure 3.b). To ensure that pollutants and moisture will not contaminate the structure from the side, it is fully enclosed by a seal-ring [2]. Table I indicates drawn metal spacing, width and serpentine length. Devices with pad width varying from 30 μm to 130 μm with a step of 20 μm have been designed. To remain compatible with 90nm probing equipment, pads spacing and height are kept to 60 μm and 70 μm , respectively.

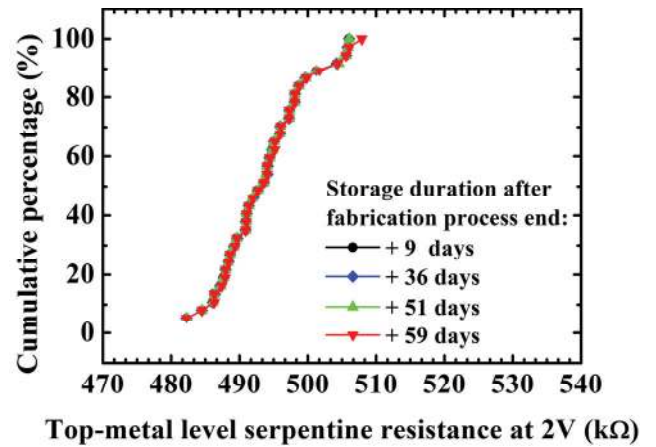
Figure 6: Top-metal level serpentine resistance at 2 V of the structure with 30 μm -wide pads measured after 9, 36, 51 and 59 days of storage at room condition after fabrication process end. Similar results are obtained on the two other metal levels.

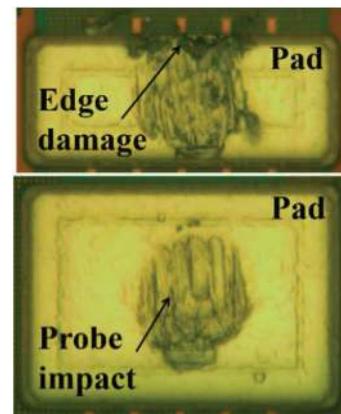
Figure 7: Optical top-view of a widely damaged 30 μm -wide pad (left) and a 50 μm -wide pad (right).

Every structure has been observed using an optical microscope and only 30 μm -wide pad edges are found to be widely damaged (Figure 7). Hence, pads have been imaged using cross-section SEM. Before probing, no crack is seen in the BEOL layers indicating that, even with the 30 μm -wide pad, there is no fabrication process issue (Figure 8).

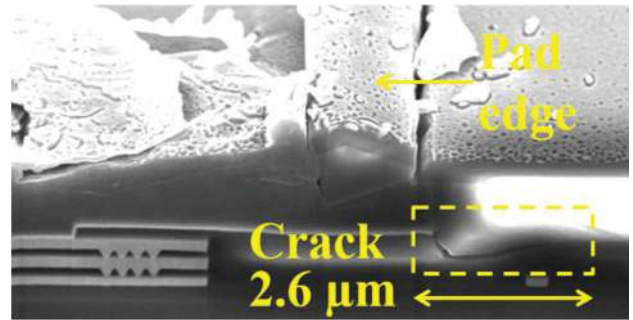
Figure 11: Cross-section SEM image of a 50µm-wide pad edge after misaligned probing. A deep crack diving from the top of the stack is observed and its length is 2.6 µm.

However, after probing, a detrimental crack diving from the top of the stack is observed (Figure 9). A well-known issue in SiOCH low-k material is their propensity to absorb moisture over time, degrading their key properties such as leakage current [2]. Therefore, we can assume that the observed leakage current increase is due to moisture ingress through the identified cracks. To confirm this assumption, a slightly misaligned probing has been performed on 50µm-wide pads just after the measurement carried out 51 days after fabrication process end. On the measurement performed only 8 days later, a leakage current increase is observed on the 50µm-wide pads structure while no increase is seen for 70, 90, 110 and 130µm-wide pads structures (Figure 10). Cross-section SEM observations of damaged 50µm-wide pads from leaky structures reveal deep cracks diving from the pads edge to BEOL layers providing a path for moisture ingress (Figure 11).

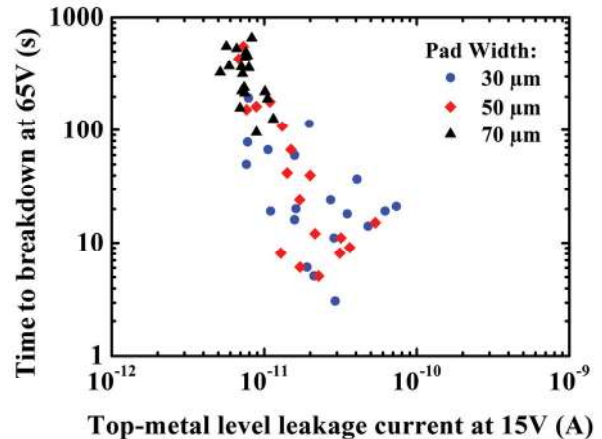
Figure 13: Time-to-breakdown of the top-metal level with 30, 50 and 70µm-wide pads after 59 days of storage as a function of leakage current measured just before TDDB measure. The lower the leakage current, the higher the time-to-breakdown.

TDDB measurements have been carried out with a bias of 65 V and a clear degradation of both time-to-breakdown (T_{BD}) median and spread is observed on structures with 30 and 50µm-wide pads i.e. on structures where cracks have been identified (Figure 12). The correlation between leakage current measured just before TDDB measurement and T_{BD} confirms the link between moisture ingress through cracks and reliability degradation of the structures (Figure 13).
