Probing impact on pad moisture tightness: a challenge for pad size reduction

Abstract— This paper underlines the damages induced by probing on narrow pads reliability of specifically designed test structures placed on dicing streets and indicates that probing during electrical test steps provokes detrimental cracks diving from the passivation through the BEOL layers providing a path for moisture ingress.

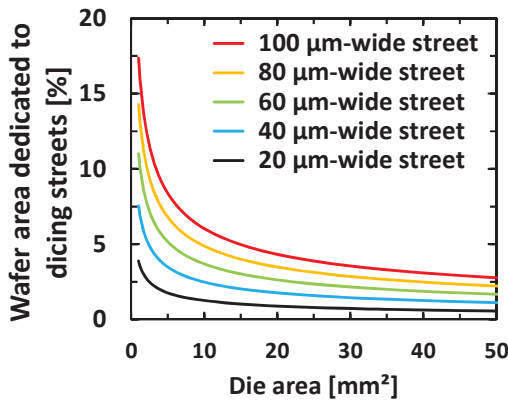
Figure 1: Percentage of wafer area dedicated to dicing streets as a function of die area. Percentages are calculated assuming a square die and same street width on X and Y. When the die is not a square, the percentage of wafer area dedicated to dicing streets might be slightly different.

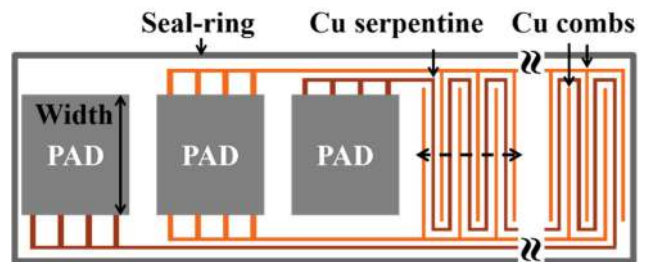
Figure 3.a: Elementary studied structure composed of a metal serpentine running between two interwoven metal combs and surrounded by a seal-ring.

The elementary studied structure is composed of a metal serpentine running between two interwoven metal combs each one being connected to a dedicated pad used for biasing and sensing (Figure 3.a). This structure is replicated in the 3 metal layers connected to independent pads allowing to test each level independently (Figure 3.b). To ensure that pollutants and moisture will not contaminate the structure from the side, it is fully enclosed by a seal-ring [2]. Table I indicates drawn metal spacing, width and serpentine length. Devices with pad width varying from 30 μm to 130 μm with a step of 20 μm have been designed. To remain compatible with 90nm probing equipment, pads spacing and height are kept to 60 μm and 70 μm , respectively.

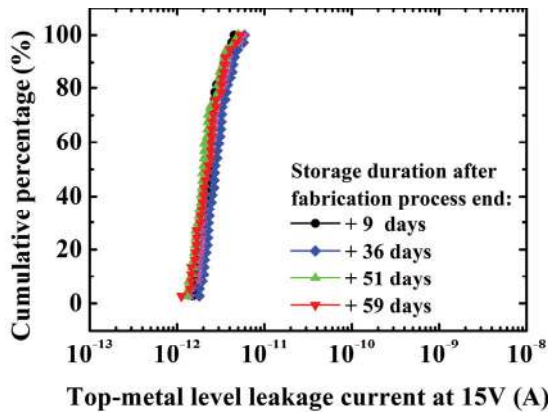
Figure 4: Top-metal level leakage current at 15 V of the structure with 70 μm -wide pads measured after 9, 36, 51 and 59 days of storage at room condition after fabrication process end. Similar results are obtained on the two other metal levels and on structures with 90, 110 and 130 μm -wide pads.

At the end of the fabrication process, structure leakage current has been regularly measured during 59 days with a bias of 15 V while wafers were stored at room condition. When the pad width is between 50 and 130 μm , leakage does not evolve as time since fabrication process end increases (Figure 4). To the contrary, for 30 μm -wide pad structures, the leakage increases dramatically right after the first measurement (Figure 5). In order to ensure that leakage current increase observed on 30 μm -wide pads structure is not the consequence of copper corrosion, serpentine resistance measurements have been carried out. Figure 6 plots the 30 μm -wide pads structure results that confirms the serpentine resistances does not evolve and thus there is no copper corrosion. Measurements for structures with wider pads produce similar distributions.

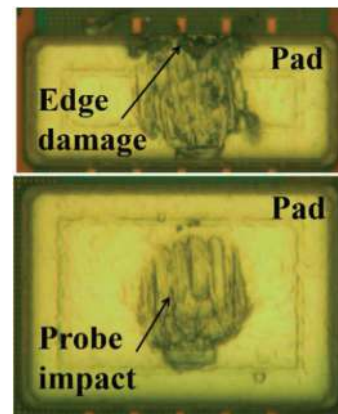
Figure 7: Optical top-view of a widely damaged 30 μm -wide pad (left) and a 50 μm -wide pad (right).

Every structure has been observed using an optical microscope and only 30 μm -wide pad edges are found to be widely damaged (Figure 7). Hence, pads have been imaged using cross-section SEM. Before probing, no crack is seen in the BEOL layers indicating that, even with the 30 μm -wide pad, there is no fabrication process issue (Figure 8).

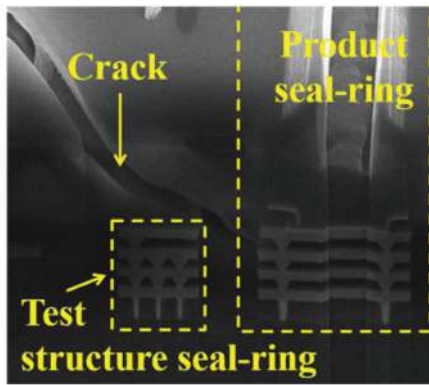
Figure 14: Cross-section SEM image of a product seal-ring reached by a deep crack diving from test structure pad edge (not shown here).

Our results indicate that probing of the test structures placed on dicing streets has a detrimental impact on narrow pad integrity as it creates cracks diving from the passivation through the BEOL layers that could even reach the product seal-ring and compromise its integrity (Figure 14). These cracks trigger an ingress of moisture after only few days of storage at room condition. This leads to significant degradation of leakage and time-to-breakdown of the low- κ intermetallic dielectric. Moreover, as moisture impacts many devices such as OxRAM [3], Flash [4], DRAM [5],[6] and MOSFET [7], it is mandatory to pay heed to narrow pad probing to avoid unreliable characterizations. Furthermore, it has been reported that wire bonding can create cracks diving from the passivation through the BEOL [8]. Consequently, to avoid damaging bonding or wrong wafer quality assessment and thus compromised chips shipment to customers, we advise to proceed carefully when reducing test structure pads dimensions or bonding pads dimensions.
