Probing impact on pad moisture tightness: a challenge for pad size reduction

Abstract— This paper underlines the damages induced by probing on narrow pads reliability of specifically designed test structures placed on dicing streets and indicates that probing during electrical test steps provokes detrimental cracks diving from the passivation through the BEOL layers providing a path for moisture ingress.

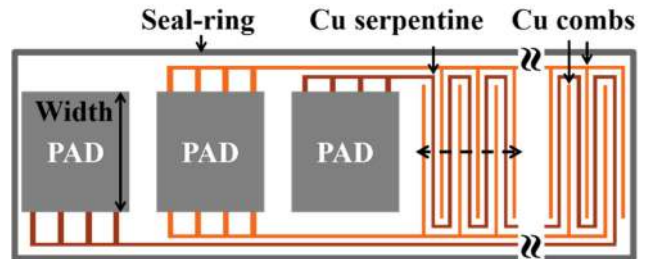
Figure 3.a: Elementary studied structure composed of a metal serpentine running between two interwoven metal combs and surrounded by a seal-ring.

The elementary studied structure is composed of a metal serpentine running between two interwoven metal combs each one being connected to a dedicated pad used for biasing and sensing (Figure 3.a). This structure is replicated in the 3 metal layers connected to independent pads allowing to test each level independently (Figure 3.b). To ensure that pollutants and moisture will not contaminate the structure from the side, it is fully enclosed by a seal-ring [2]. Table I indicates drawn metal spacing, width and serpentine length. Devices with pad width varying from 30 μm to 130 μm with a step of 20 μm have been designed. To remain compatible with 90nm probing equipment, pads spacing and height are kept to 60 μm and 70 μm , respectively.

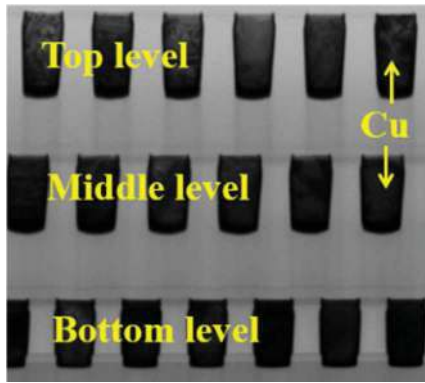
Figure 3.b: Cross-section TEM image of the test structure with the 3 metal levels. The cross-section location is indicated by the black dashed arrow on Figure 3.a.

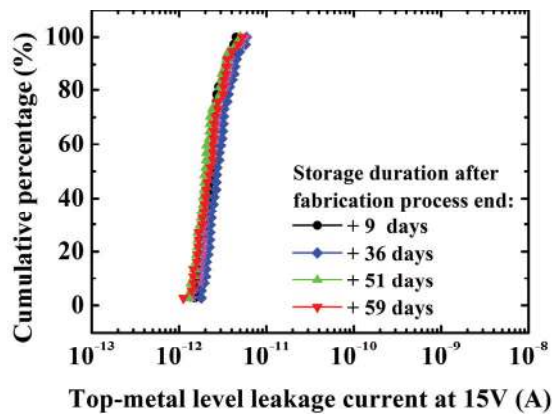
Figure 4: Top-metal level leakage current at 15 V of the structure with 70 μm -wide pads measured after 9, 36, 51 and 59 days of storage at room condition after fabrication process end. Similar results are obtained on the two other metal levels and on structures with 90, 110 and 130 μm -wide pads.

At the end of the fabrication process, structure leakage current has been regularly measured during 59 days with a bias of 15 V while wafers were stored at room condition. When the pad width is between 50 and 130 μm , leakage does not evolve as time since fabrication process end increases (Figure 4). To the contrary, for 30 μm -wide pad structures, the leakage increases dramatically right after the first measurement (Figure 5). In order to ensure that leakage current increase observed on 30 μm -wide pads structure is not the consequence of copper corrosion, serpentine resistance measurements have been carried out. Figure 6 plots the 30 μm -wide pads structure results that confirms the serpentine resistances does not evolve and thus there is no copper corrosion. Measurements for structures with wider pads produce similar distributions.

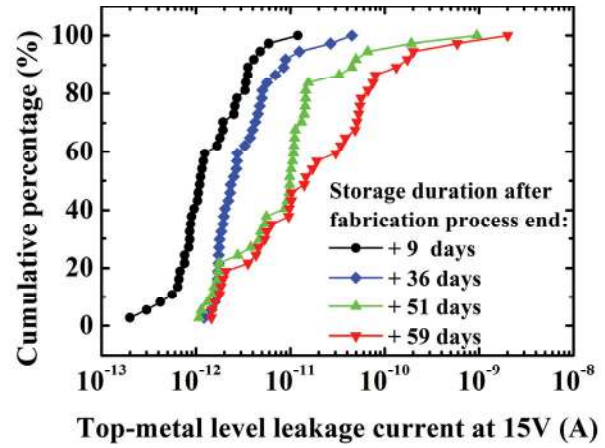
Figure 5: Top-metal level leakage current at 15 V of the structure with 30 μm -wide pads measured after 9, 36, 51 and 59 days of storage at room condition after fabrication process end. Similar results are obtained on the two other metal levels.

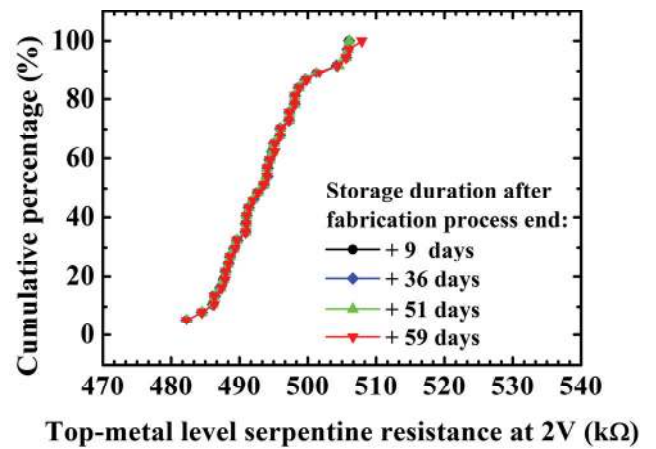
Figure 6: Top-metal level serpentine resistance at 2 V of the structure with 30 μm -wide pads measured after 9, 36, 51 and 59 days of storage at room condition after fabrication process end. Similar results are obtained on the two other metal levels.

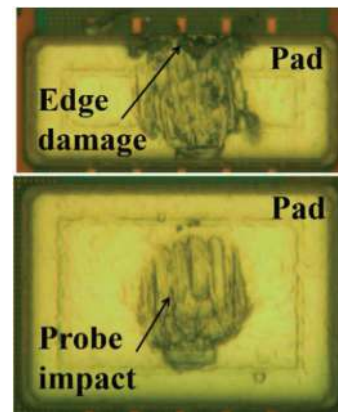
Figure 7: Optical top-view of a widely damaged 30 μm -wide pad (left) and a 50 μm -wide pad (right).

Every structure has been observed using an optical microscope and only 30 μm -wide pad edges are found to be widely damaged (Figure 7). Hence, pads have been imaged using cross-section SEM. Before probing, no crack is seen in the BEOL layers indicating that, even with the 30 μm -wide pad, there is no fabrication process issue (Figure 8).

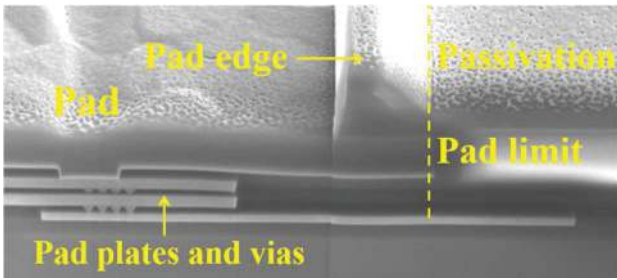
Figure 8: Cross-section SEM image of a 30µm-wide pad and pad edge before any probing. Neither cracks nor fabrication process issue is observed.

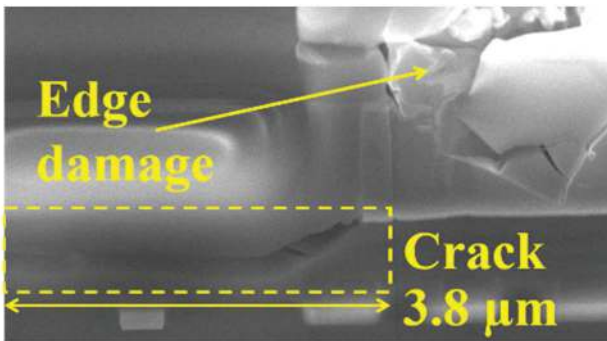
Figure 9: Cross-section SEM image of a 30µm-wide pad edge after probing. A deep crack diving from the top of the BEOL layers is observed and is more than 4µm-long.

However, after probing, a detrimental crack diving from the top of the stack is observed (Figure 9). A well-known issue in SiOCH low-k material is their propensity to absorb moisture over time, degrading their key properties such as leakage current [2]. Therefore, we can assume that the observed leakage current increase is due to moisture ingress through the identified cracks. To confirm this assumption, a slightly misaligned probing has been performed on 50µm-wide pads just after the measurement carried out 51 days after fabrication process end. On the measurement performed only 8 days later, a leakage current increase is observed on the 50µm-wide pads structure while no increase is seen for 70, 90, 110 and 130µm-wide pads structures (Figure 10). Cross-section SEM observations of damaged 50µm-wide pads from leaky structures reveal deep cracks diving from the pads edge to BEOL layers providing a path for moisture ingress (Figure 11).

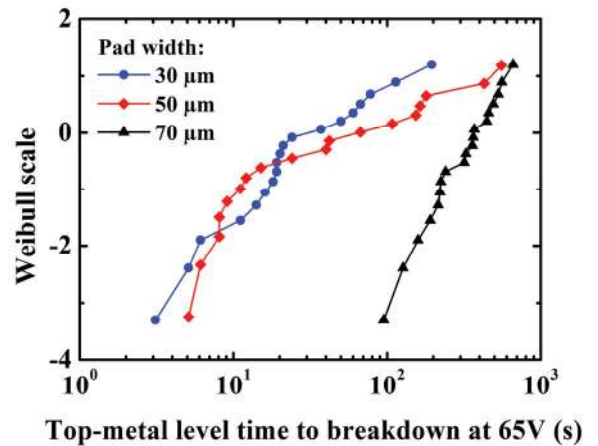
Figure 12: Weibull distribution of the time-to-breakdown of the top-metal level structures with 30-, 50- and 70-µm wide pads measured after 59 days of storage at room condition.

TDDB measurements have been carried out with a bias of 65 V and a clear degradation of both time-to-breakdown (T_{BD}) median and spread is observed on structures with 30 and 50µm-wide pads i.e. on structures where cracks have been identified (Figure 12). The correlation between leakage current measured just before TDDB measurement and T_{BD} confirms the link between moisture ingress through cracks and reliability degradation of the structures (Figure 13).

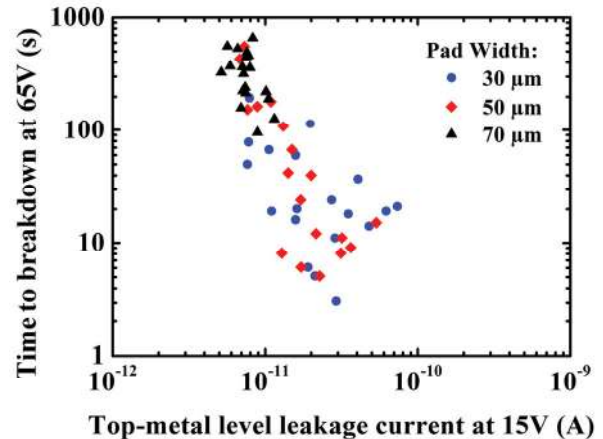
Figure 13: Time-to-breakdown of the top-metal level with 30, 50 and 70µm-wide pads after 59 days of storage as a function of leakage current measured just before TDDB measure. The lower the leakage current, the higher the time-to-breakdown.
