Probing impact on pad moisture tightness: A challenge for pad size reduction

Probing impact on pad moisture tightness: a challenge for pad size reduction

Abstract— This paper underlines the damages induced by probing on narrow pads reliability of specifically designed test structures placed on dicing streets and indicates that probing during electrical test steps provokes detrimental cracks diving from the passivation through the BEOL layers providing a path for moisture ingress.

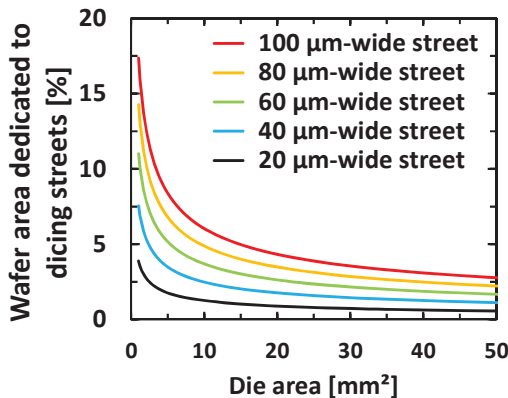
Figure 1: Percentage of wafer area dedicated to dicing streets as a function of die area. Percentages are calculated assuming a square die and same street width on X and Y. When the die is not a square, the percentage of wafer area dedicated to dicing streets might be slightly different.

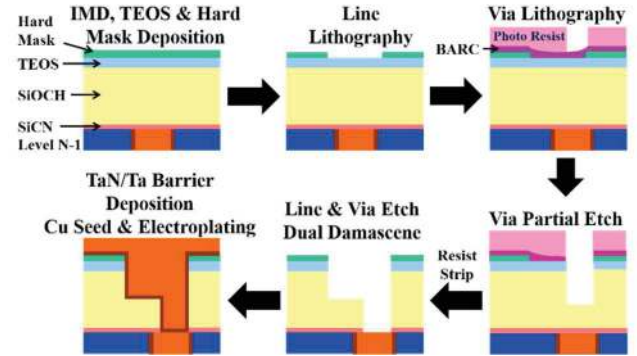
Figure 2: Process flow used to fabricate one metal layer. To create successive metal layers, this sequence is repeated

In many applications such as automotive and medical, chips must be highly reliable and thus, pass challenging quality assessments including Wafer-Level Reliability evaluation, exhaustive Parametric Test and extended Electrical Wafer Sort. To fulfill such demanding requirements, a large number of test structures – placed in wafer dicing streets – are needed. However, the smaller the die, the higher the wafer area dedicated to dicing streets (Figure 1). Therefore, a way to reduce the dicing streets area is to reduce the street width. To this extent, structures with narrower pads are mandatory. Probing equipment having a limited precision, hitting small pads in reduced street width might provoke non-previously existing reliability issues in test structures. In this paper, the impact of probing on narrow pads integrity of specifically designed test structures is evaluated with dedicated test methods. These test structures are embedded in an automotive-qualified 90nm-node of a 200mm process line with 3 dual-damascene copper-levels Back-End-Of-Line (BEOL) with SiCOH low- κ intermetallic dielectric (IMD), 45 nm-thick SiCN capping layer and Ta/TaN diffusion barrier [1]. Figure 2 describes the process flow of one metal layer.

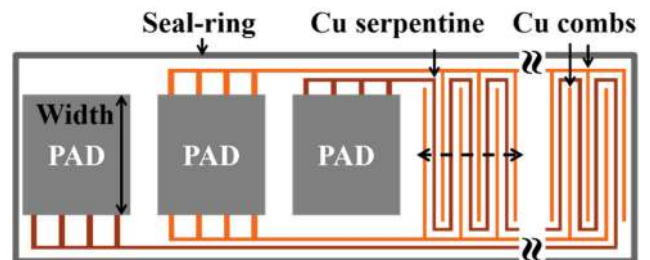
Figure 3.a: Elementary studied structure composed of a metal serpentine running between two interwoven metal combs and surrounded by a seal-ring.

The elementary studied structure is composed of a metal serpentine running between two interwoven metal combs each one being connected to a dedicated pad used for biasing and sensing (Figure 3.a). This structure is replicated in the 3 metal layers connected to independent pads allowing to test each level independently (Figure 3.b). To ensure that pollutants and moisture will not contaminate the structure from the side, it is fully enclosed by a seal-ring [2]. Table I indicates drawn metal spacing, width and serpentine length. Devices with pad width varying from 30 μm to 130 μm with a step of 20 μm have been designed. To remain compatible with 90nm probing equipment, pads spacing and height are kept to 60 μm and 70 μm , respectively.

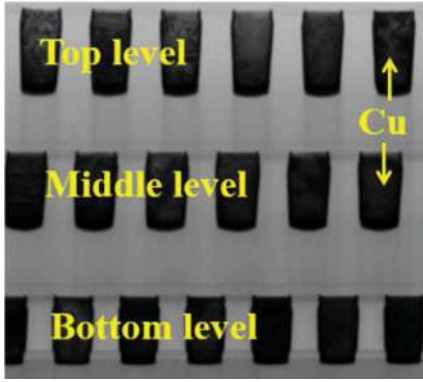
Figure 3.b: Cross-section TEM image of the test structure with the 3 metal levels. The cross-section location is indicated by the black dashed arrow on Figure 3.a.

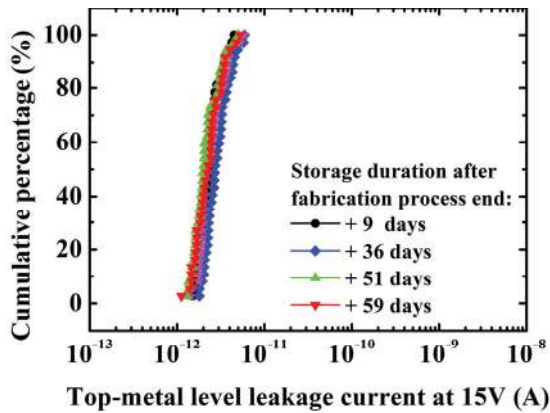
Figure 4: Top-metal level leakage current at 15 V of the structure with 70 μm -wide pads measured after 9, 36, 51 and 59 days of storage at room condition after fabrication process end. Similar results are obtained on the two other metal levels and on structures with 90, 110 and 130 μm -wide pads.

At the end of the fabrication process, structure leakage current has been regularly measured during 59 days with a bias of 15 V while wafers were stored at room condition. When the pad width is between 50 and 130 μm , leakage does not evolve as time since fabrication process end increases (Figure 4). To the contrary, for 30 μm -wide pad structures, the leakage increases dramatically right after the first measurement (Figure 5). In order to ensure that leakage current increase observed on 30 μm -wide pads structure is not the consequence of copper corrosion, serpentine resistance measurements have been carried out. Figure 6 plots the 30 μm -wide pads structure results that confirms the serpentine resistances does not evolve and thus there is no copper corrosion. Measurements for structures with wider pads produce similar distributions.

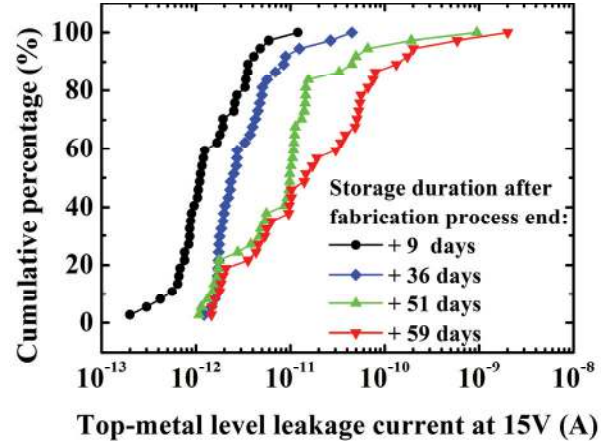
Figure 5: Top-metal level leakage current at 15 V of the structure with 30 μm -wide pads measured after 9, 36, 51 and 59 days of storage at room condition after fabrication process end. Similar results are obtained on the two other metal levels.

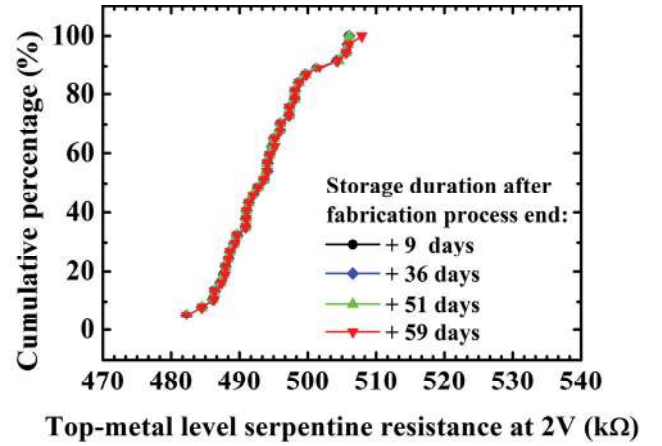
Figure 6: Top-metal level serpentine resistance at 2 V of the structure with 30 μm -wide pads measured after 9, 36, 51 and 59 days of storage at room condition after fabrication process end. Similar results are obtained on the two other metal levels.

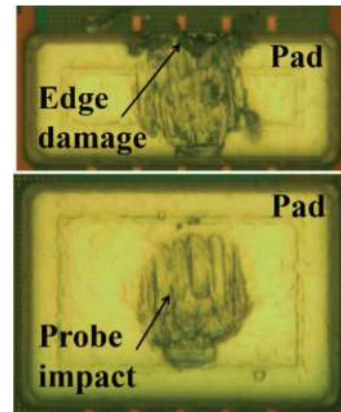
Figure 7: Optical top-view of a widely damaged 30 μm -wide pad (left) and a 50 μm -wide pad (right).

Every structure has been observed using an optical microscope and only 30 μm -wide pad edges are found to be widely damaged (Figure 7). Hence, pads have been imaged using cross-section SEM. Before probing, no crack is seen in the BEOL layers indicating that, even with the 30 μm -wide pad, there is no fabrication process issue (Figure 8).

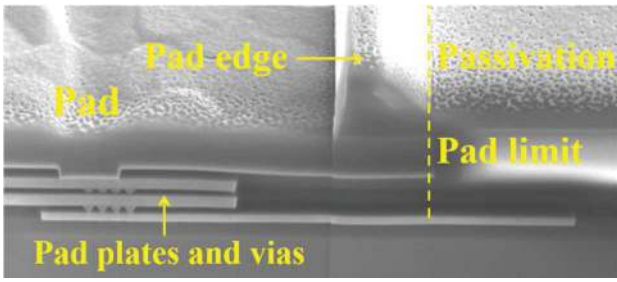
Figure 8: Cross-section SEM image of a 30µm-wide pad and pad edge before any probing. Neither cracks nor fabrication process issue is observed.

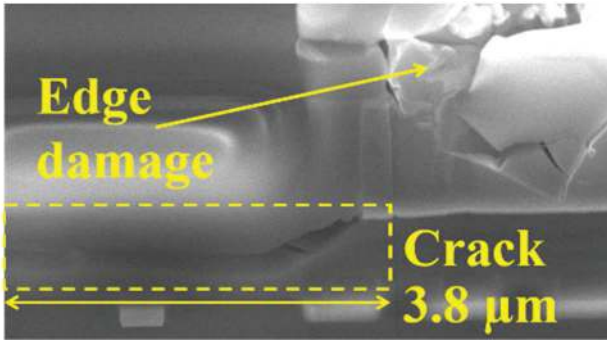
Figure 9: Cross-section SEM image of a 30µm-wide pad edge after probing. A deep crack diving from the top of the BEOL layers is observed and is more than 4µm-long.

However, after probing, a detrimental crack diving from the top of the stack is observed (Figure 9). A well-known issue in SiOCH low-k material is their propensity to absorb moisture over time, degrading their key properties such as leakage current [2]. Therefore, we can assume that the observed leakage current increase is due to moisture ingress through the identified cracks. To confirm this assumption, a slightly misaligned probing has been performed on 50µm-wide pads just after the measurement carried out 51 days after fabrication process end. On the measurement performed only 8 days later, a leakage current increase is observed on the 50µm-wide pads structure while no increase is seen for 70, 90, 110 and 130µm-wide pads structures (Figure 10). Cross-section SEM observations of damaged 50µm-wide pads from leaky structures reveal deep cracks diving from the pads edge to BEOL layers providing a path for moisture ingress (Figure 11).

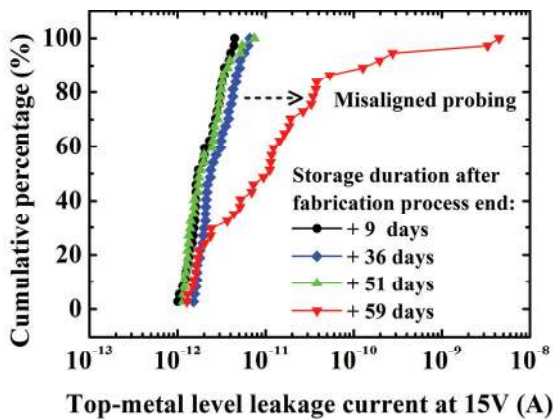
Figure 10: Top-metal level leakage current at 15 V of the structure with 50 µm-wide pads measured after 9, 36, 51 and 59 days of storage at room condition after fabrication process end. Similar results are obtained on the two other metal levels.

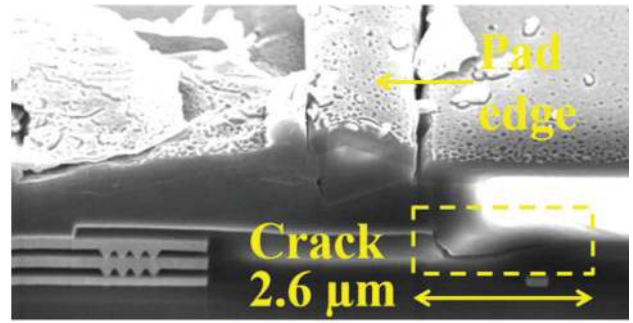
Figure 11: Cross-section SEM image of a 50µm-wide pad edge after misaligned probing. A deep crack diving from the top of the stack is observed and its length is 2.6 µm.

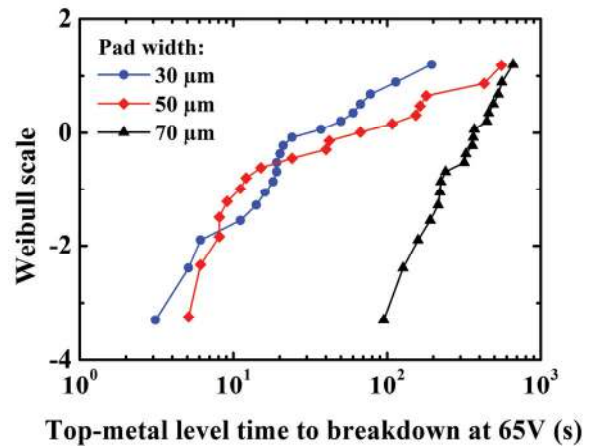
Figure 12: Weibull distribution of the time-to-breakdown of the top-metal level structures with 30-, 50- and 70-µm wide pads measured after 59 days of storage at room condition.

TDDB measurements have been carried out with a bias of 65 V and a clear degradation of both time-to-breakdown (T_{BD}) median and spread is observed on structures with 30 and 50µm-wide pads i.e. on structures where cracks have been identified (Figure 12). The correlation between leakage current measured just before TDDB measurement and T_{BD} confirms the link between moisture ingress through cracks and reliability degradation of the structures (Figure 13).

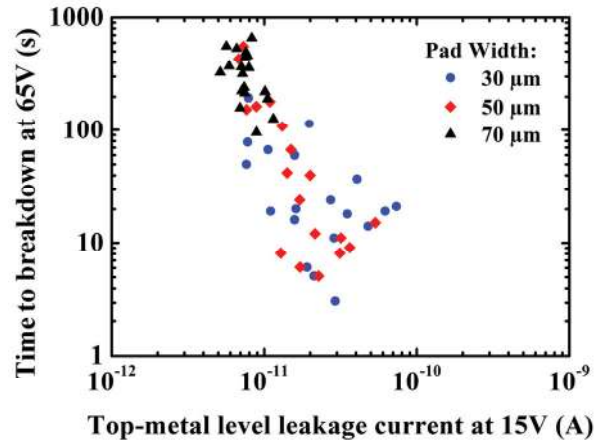
Figure 13: Time-to-breakdown of the top-metal level with 30, 50 and 70µm-wide pads after 59 days of storage as a function of leakage current measured just before TDDB measure. The lower the leakage current, the higher the time-to-breakdown.

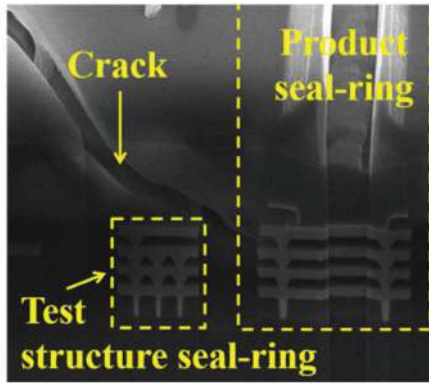
Figure 14: Cross-section SEM image of a product seal-ring reached by a deep crack diving from test structure pad edge (not shown here).

Our results indicate that probing of the test structures placed on dicing streets has a detrimental impact on narrow pad integrity as it creates cracks diving from the passivation through the BEOL layers that could even reach the product seal-ring and compromise its integrity (Figure 14). These cracks trigger an ingress of moisture after only few days of storage at room condition. This leads to significant degradation of leakage and time-to-breakdown of the low- κ intermetallic dielectric. Moreover, as moisture impacts many devices such as OxRAM [3], Flash [4], DRAM [5],[6] and MOSFET [7], it is mandatory to pay heed to narrow pad probing to avoid unreliable characterizations. Furthermore, it has been reported that wire bonding can create cracks diving from the passivation through the BEOL [8]. Consequently, to avoid damaging bonding or wrong wafer quality assessment and thus compromised chips shipment to customers, we advise to proceed carefully when reducing test structure pads dimensions or bonding pads dimensions.
