Probing impact on pad moisture tightness: a challenge for pad size reduction

Abstract— This paper underlines the damages induced by probing on narrow pads reliability of specifically designed test structures placed on dicing streets and indicates that probing during electrical test steps provokes detrimental cracks diving from the passivation through the BEOL layers providing a path for moisture ingress.

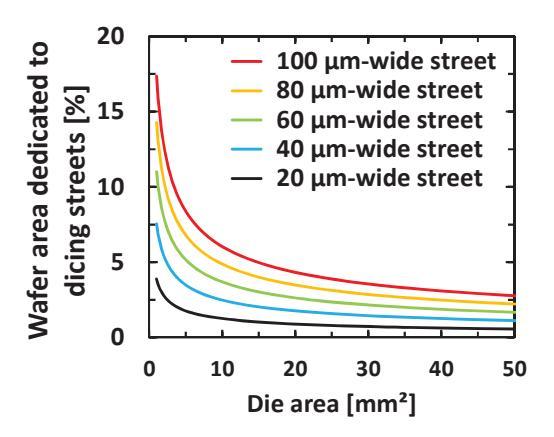
Figure 1: Percentage of wafer area dedicated to dicing streets as a function of die area. Percentages are calculated assuming a square die and same street width on X and Y. When the die is not a square, the percentage of wafer area dedicated to dicing streets might be slightly different.

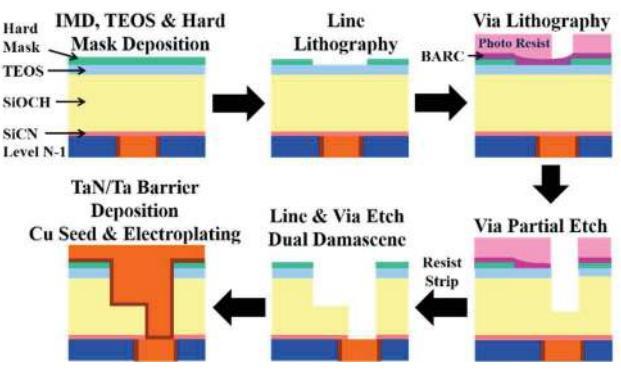
Figure 2: Process flow used to fabricate one metal layer. To create successive metal layers, this sequence is repeated

In many applications such as automotive and medical, chips must be highly reliable and thus, pass challenging quality assessments including Wafer-Level Reliability evaluation, exhaustive Parametric Test and extended Wafer Sort. To fulfill such demanding Electrical requirements, a large number of test structures - placed in wafer dicing streets - are needed. However, the smaller the die, the higher the wafer area dedicated to dicing streets (Figure 1). Therefore, a way to reduce the dicing streets area is to reduce the street width. To this extent, structures with narrower pads are mandatory. Probing equipment having a limited precision, hitting small pads in reduced street width might provoke non-previously existing reliability issues in test structures. In this paper, the impact of probing on narrow pads integrity of specifically designed test structures is evaluated with dedicated test methods. These test structures are embedded in an automotive-qualified 90nm-node of a 200mm process line with 3 dual-damascene copper-levels Back-End-Of-Line (BEOL) with SiCOH low-k intermetallic dielectric (IMD), 45 nm-thick SiCN capping layer and Ta/TaN diffusion barrier [1]. Figure 2 describes the process flow of one metal layer.

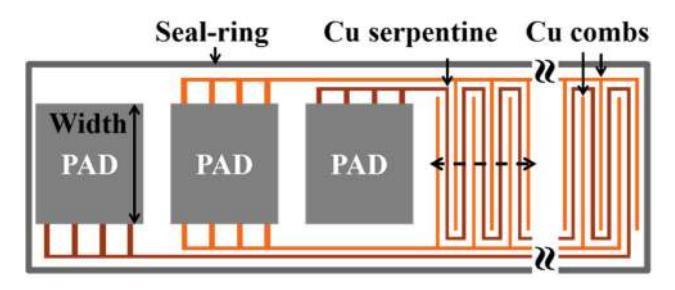
Figure 3.a: Elementary studied structure composed of a metal serpentine running between two interwoven metal combs and surrounded by a seal-ring.

The elementary studied structure is composed of a metal serpentine running between two interwoven metal combs each one being connected to a dedicated pad used for biasing and sensing (Figure 3.a). This structure is replicated in the 3 metal layers connected to independent pads allowing to test each level independently (Figure 3.b). To ensure that pollutants and moisture will not contaminate the structure from the side, it is fully enclosed by a seal-ring [2]. Table I indicates drawn metal spacing, width and serpentine length. Devices with pad width varying from 30 μ m to 130 μ m with a step of 20 μ m have been designed. To remain compatible with 90nm probing equipment, pads spacing and height are kept to 60 μ m and 70 μ m, respectively.

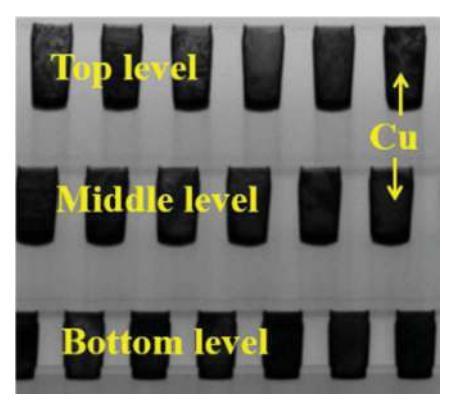
Figure 3.b: Cross-section TEM image of the test structure with the 3 metal levels. The cross-section location is indicated by the black dashed arrow on Figure 3.a.

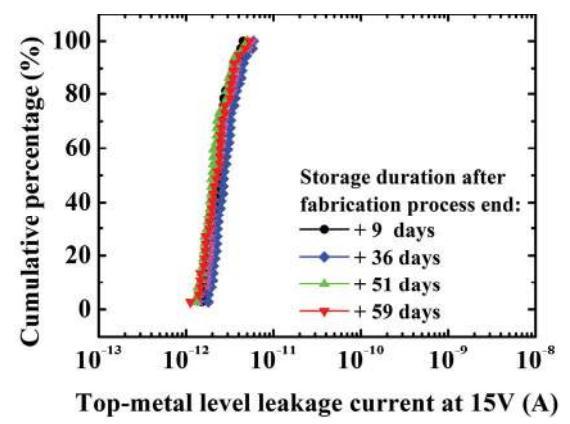
Figure 4: Top-metal level leakage current at 15 V of the structure with 70 μ m-wide pads measured after 9, 36, 51 and 59 days of storage at room condition after fabrication process end. Similar results are obtained on the two other metal levels and on structures with 90, 110 and 130 μ m-wide pads.

At the end of the fabrication process, structure leakage current has been regularly measured during 59 days with a bias of 15 V while wafers were stored at room condition. When the pad width is between 50 and 130 μ m, leakage does not evolve as time since fabrication process end increases (Figure 4). To the contrary, for 30 μ m-wide pad structures, the leakage increases dramatically right after the first measurement (Figure 5).In order to ensure that leakage current increase observed on 30 μ m-wide pads structure is not the consequence of copper corrosion, serpentine resistance measurements have been carried out. Figure 6 plots the 30 μ m-wide pads structure results that confirms the serpentine resistances does not evolve and thus there is no copper corrosion. Measurements for structures with wider pads produce similar distributions.

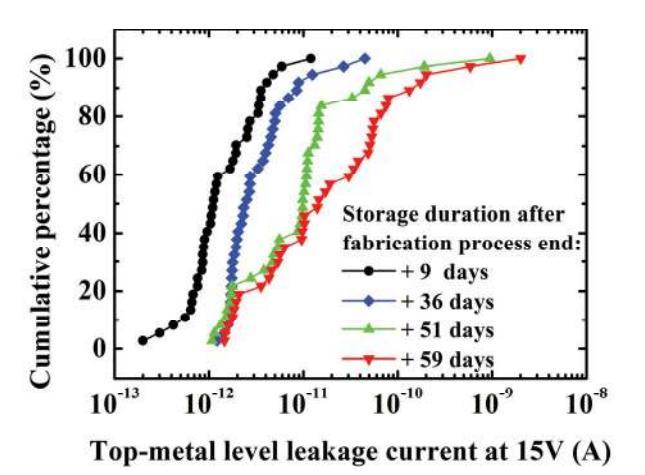
Figure 5: Top-metal level leakage current at 15 V of the structure with 30μ m-wide pads measured after 9, 36, 51 and 59 days of storage at room condition after fabrication process end. Similar results are obtained on the two other metal levels.

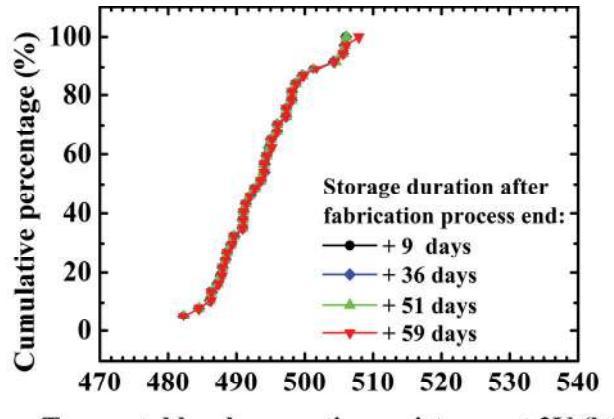
Figure 6: Top-metal level serpentine resistance at 2 V of the structure with 30μ m-wide pads measured after 9, 36, 51 and 59 days of storage at room condition after fabrication process end. Similar results are obtained on the two other metal levels.

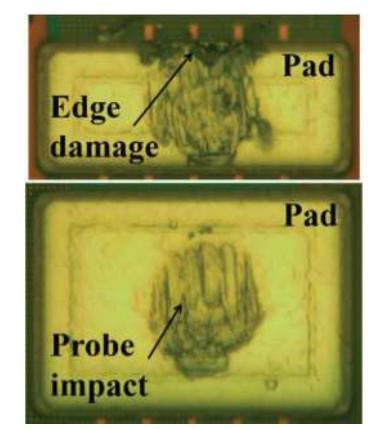
Figure 7: Optical top-view of a widely damaged 30μ m-wide pad (left) and a 50μ m-wide pad (right).

Every structure has been observed using an optical microscope and only 30 μ m-wide pad edges are found to be widely damaged (Figure 7). Hence, pads have been imaged using cross-section SEM. Before probing, no crack is seen in the BEOL layers indicating that, even with the 30 μ m-wide pad, there is no fabrication process issue (Figure 8).

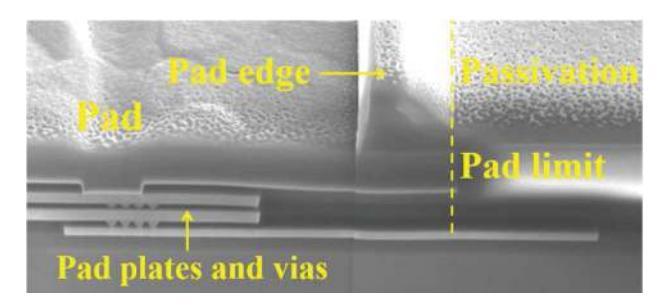
Figure 8: Cross-section SEM image of a $30\mu m$ -wide pad and pad edge before any probing. Neither cracks nor fabrication process issue is observed.

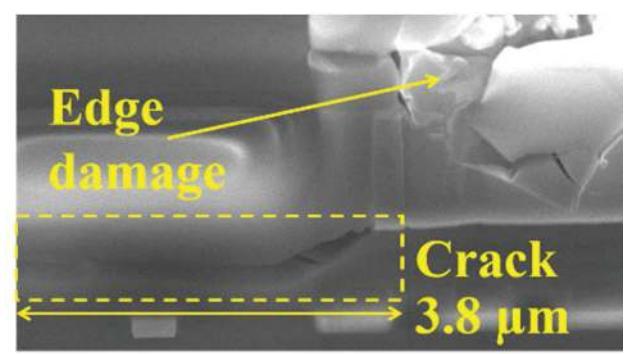
Figure 9: Cross-section SEM image of a 30μ m-wide pad edge after probing. A deep crack diving from the top of the BEOL layers is observed and is more than 4μ m-long.

However, after probing, a detrimental crack diving from the top of the stack is observed (Figure 9). A well-known issue in SiOCH low-k material is their propensity to absorb moisture over time, degrading their key properties such as leakage current [2]. Therefore, we can assume that the observed leakage current increase is due to moisture ingress through the identified cracks. To confirm this assumption, a slightly misaligned probing has been performed on 50µmwide pads just after the measurement carried out 51 days after fabrication process end. On the measurement performed only 8 days later, a leakage current increase is observed on the 50µm-wide pads structure while no increase is seen for 70, 90, 110 and 130µm-wide pads structures (Figure 10). Crosssection SEM observations of damaged 50µm-wide pads from leaky structures reveal deep cracks diving from the pads edge to BEOL layers providing a path for moisture ingress (Figure 11).

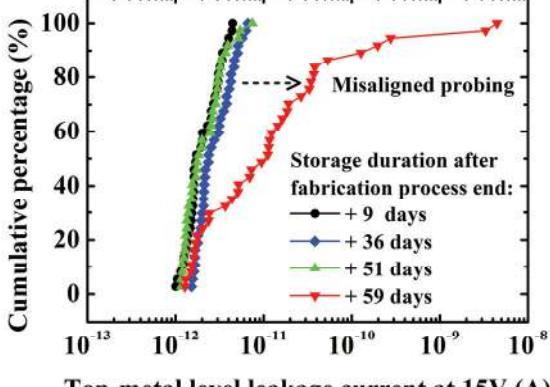
Figure 10: Top-metal level leakage current at 15 V of the structure with 50 μ m-wide pads measured after 9, 36, 51 and 59 days of storage at room condition after fabrication process end. Similar results are obtained on the two other metal levels.

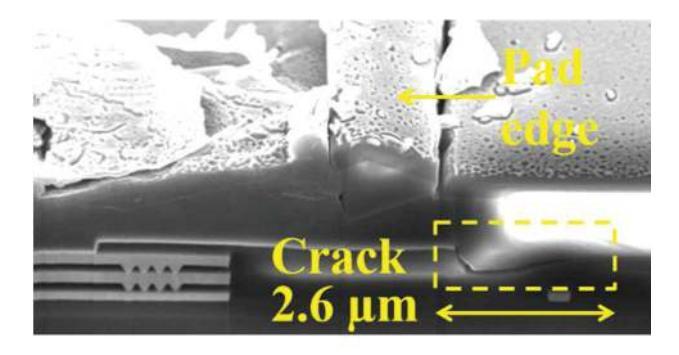
Figure 11: Cross-section SEM image of a 50μ m-wide pad edge after misaligned probing. A deep crack diving from the top of the stack is observed and its length is 2.6 μ m.

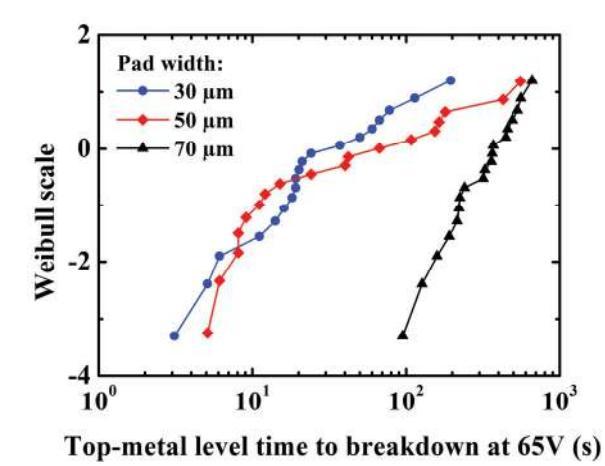
Figure 12: Weibull distribution of the time-to-breakdown of the top-metal level structures with 30-, 50- and 70- μ m wide pads measured after 59 days of storage at room condition.

TDDB measurements have been carried out with a bias of 65 V and a clear degradation of both time-to-breakdown (T_{BD}) median and spread is observed on structures with 30 and 50µm-wide pads i.e. on structures where cracks have been identified (Figure 12). The correlation between leakage current measured just before TDDB measurement and T_{BD} confirms the link between moisture ingress through cracks and reliability degradation of the structures (Figure 13).

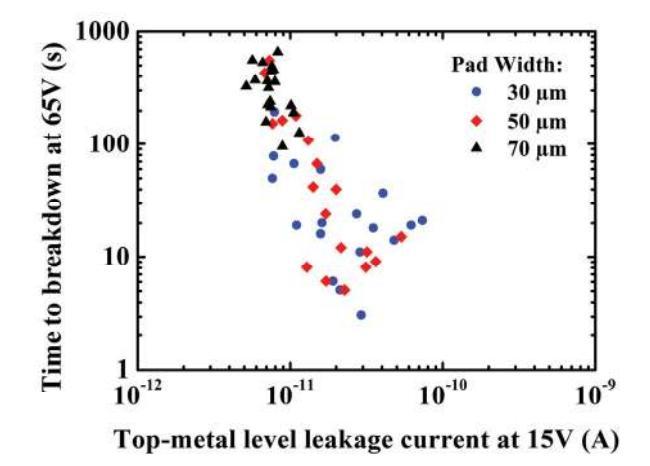
Figure 13: Time-to-breakdown of the top-metal level with 30, 50 and 70 μ m-wide pads after 59 days of storage as a function of leakage current measured just before TDDB measure. The lower the leakage current, the higher the time-to-breakdown.

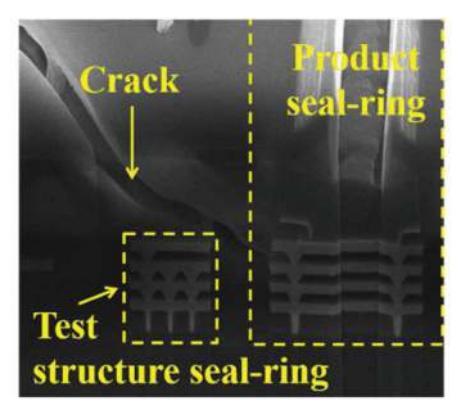
Figure 14: Cross-section SEM image of a product seal-ring reached by a deep crack diving from test structure pad edge (not shown here).

Our results indicate that probing of the test structures placed on dicing streets has a detrimental impact on narrow pad integrity as it creates cracks diving from the passivation through the BEOL layers that could even reach the product seal-ring and compromise its integrity (Figure 14). These cracks trigger an ingress of moisture after only few days of storage at room condition. This leads to significant degradation of leakage and time-to-breakdown of the low-k intermetallic dielectric. Moreover, as moisture impacts many devices such as OxRAM [3], Flash [4], DRAM [5], [6] and MOSFET [7], it is mandatory to pay heed to narrow pad probing to avoid unreliable characterizations. Furthermore, it has been reported that wire bonding can create cracks diving from the passivation through the BEOL [8]. Consequently, to avoid damaging bonding or wrong wafer quality assessment and thus compromised chips shipment to customers, we advise to proceed carefully when reducing test structure pads dimensions or bonding pads dimensions.
