Shake table tests on 1:2 reduced scale masonry house with the application of horizontal seismic bands

Santosh Yadav, Yannick Sieffert, Florent Vieux-Champagne, Yann Malecot,
Majid Hajmirbaba, Luis Arléo, Eugénie Crété, Philippe Garnier

Santosh Yadav, Yannick Sieffert, Florent Vieux-Champagne, Yann Malecot, Majid Hajmirbaba, et al..
Shake table tests on 1:2 reduced scale masonry house with the application of horizontal seismic bands.
Engineering Structures, 2023, 283, pp.115897. 10.1016/j.engstruct.2023.115897 . hal-04132754

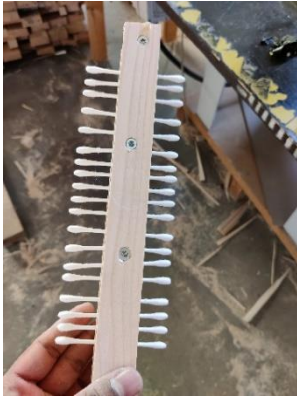
To prepare the wall surfaces, any loose particles were cleaned with a dry cloth, then two coats of white mat paint were applied to provide proper contrast. After drying for a couple of hours, an array of cotton buds was prepared, as shown in Fig. 7, and used to stamp black dots on the wall surface with mat black paint to avoid glossy reflections. This array expedited the process, and the black dots' density was later increased using single cotton buds. The grayscale image histogram for the speckle pattern surface had two peaks, as shown in Fig. 8, indicating even black and white distribution.

Fig. 7 Arrangement of cotton bud for application of black speckles pattern

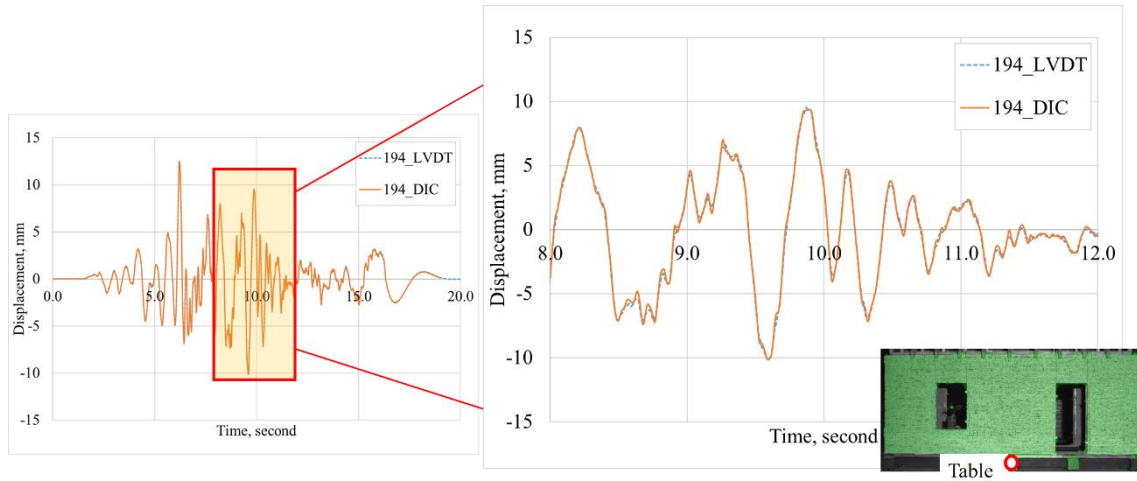
The DIC output for field displacement was validated against the LVDT results for table displacement. A point on the metal frame (as indicated in Fig. 10) was selected, and the absolute displacement was extracted. The comparison of the table displacement from LVDT and DIC was made in the time-series domain (Fig. 10) and in the frequency domain using Fast Fourier Transfer (Fig. 12 (a)) at 194 GUA. The results from DIC were found to be in good agreement with the LVDT results.

Fig. 10. Comparison of table displacement measured from LVDT and DIC in the time domain at 194 GUA

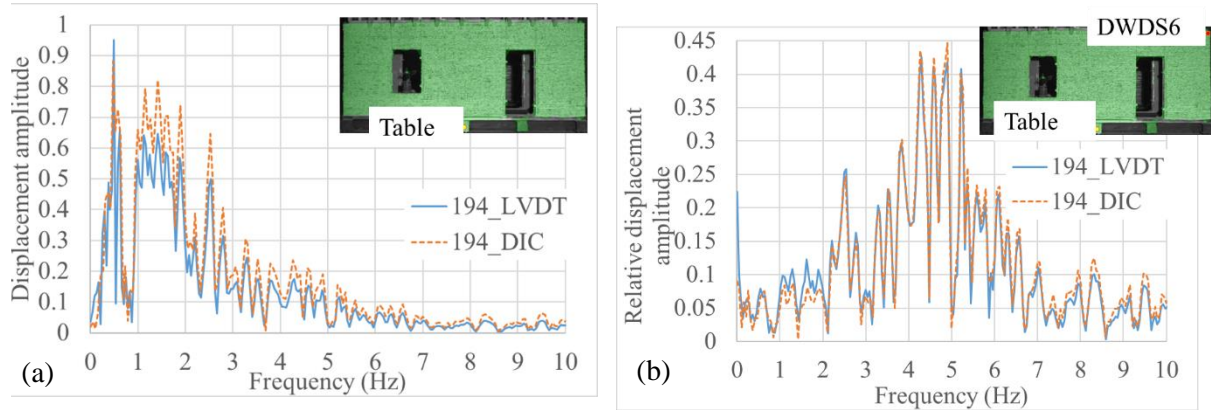
The comparison of relative displacement in the frequency domain (Fig. 12 (b)) shows good agreement between the results from DIC and DWDS6. This suggests that the subset size chosen

for DIC is appropriate for in-plane walls. Therefore, the DIC results for the displacement field are used for further analysis. The same validation process is applied to all other tests with varying signal magnitudes and house model.

Fig. 12. Validation of (a) absolute and (b) relative displacement of shake table and RC model at GUA 194 in the frequency domain

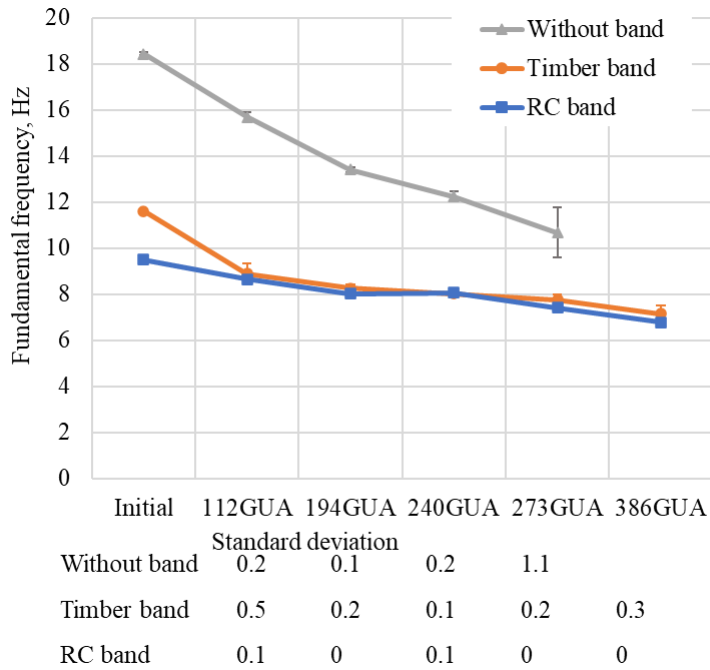
The fundamental frequency of structures is determined by analyzing the peaks in Frequency Response Function (FRF) obtained from the accelerometer data recorded during the application of a random white noise signal after each loading signal. The FRF results from the test exhibit a wavy pattern as white noise signal contain frequency ranging from 0.5 to 50 Hz. This makes it difficult to accurately identify the peak at resonating frequency. To overcome this challenge, standardization was necessary. The Gaussian curve fitting approach was used to standardize the FRF results. With the help of Gaussian curve fitting (MATLAB tool), a smooth curve was obtained from discrete FRF point results, which was finally used to identify the fundamental frequencies. The frequency corresponding to the peak response gives the fundamental frequency of the structures. The average results from the four BA₁₋₄ measuring along the loading direction are used to obtain the house model's fundamental frequency after each loading signal. The variation in the fundamental frequency for each of the three house model is shown in Fig. 13, along the error bars are indicating the standard deviation (SD). The high SD for the house without a band at 273GUA is due to the wide crack in the walls, resulting in differences in displacement and frequency. The fundamental frequency of structure varies with the application of a seismic band. The natural frequency for the house without a band is declining at a faster rate, whereas for the houses with a seismic band, the change is gradual, and the rate of degradation is comparable. For 386GUA loading (house without a band), all the measurement sensors were removed because of the risk of collapse and sensor damage.

Fig. 13. Variation in the fundamental frequency after each loading signal

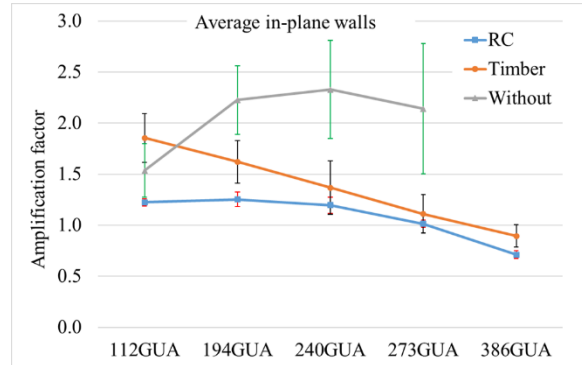
Fig. 17 represents the variation of amplification factor during each loading signal for the three house models. The average amplification value is calculated by taking the peak acceleration measured by each accelerometer and dividing it by the peak acceleration applied to the shake

table. The error bars in the graph indicate the standard deviation value, which can increase due to structural damage causing a difference in displacement rate. For both timber and RC band house models, the amplification follows the declining trend, which is due to easily sliding of the top part of the structure after the interface at the lintel band is damaged. The amplification increases with the increasing loading signal for the house without a band and then decreases after the 240 GUA signal. The standard deviation (SD) for the house without a band is high because of extensive damage to the structure after each loading signal. The SD is lower for house with timber band and quite low for that with RC band, indicating an enhanced paraseismic behavior. Therefore, the seismic band helps to reduce overall amplification at the top of the structure by allowing each section to slide as an individual block.

Fig. 17. Average in-plane walls acceleration amplification at various loading

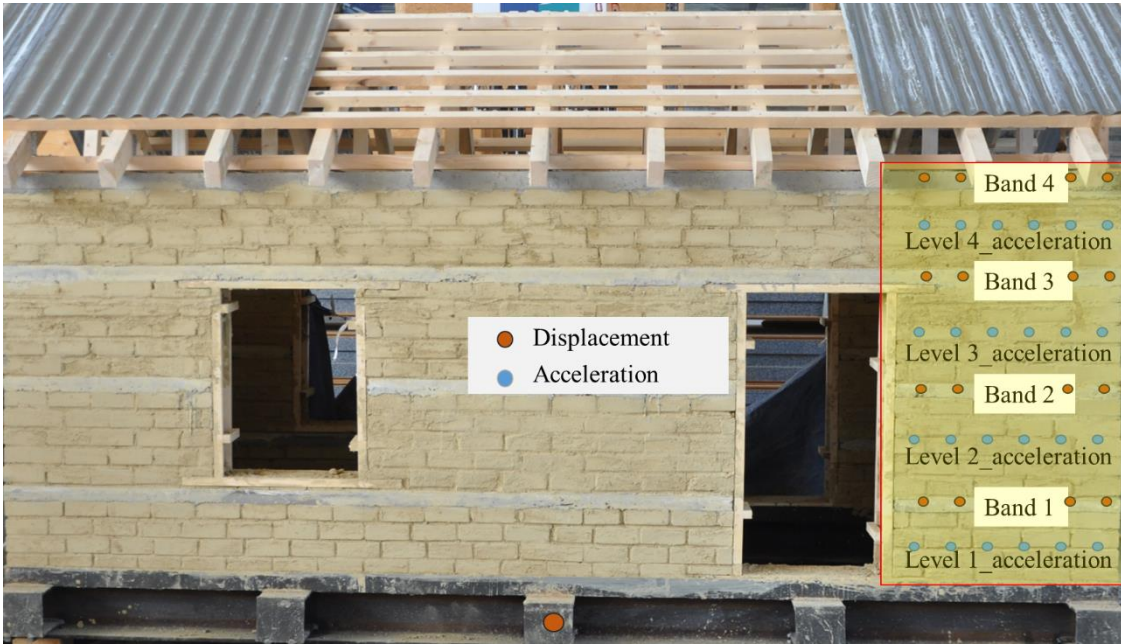
Fig. 18. Region selected for energy dissipation with a location represented for displacement and acceleration points

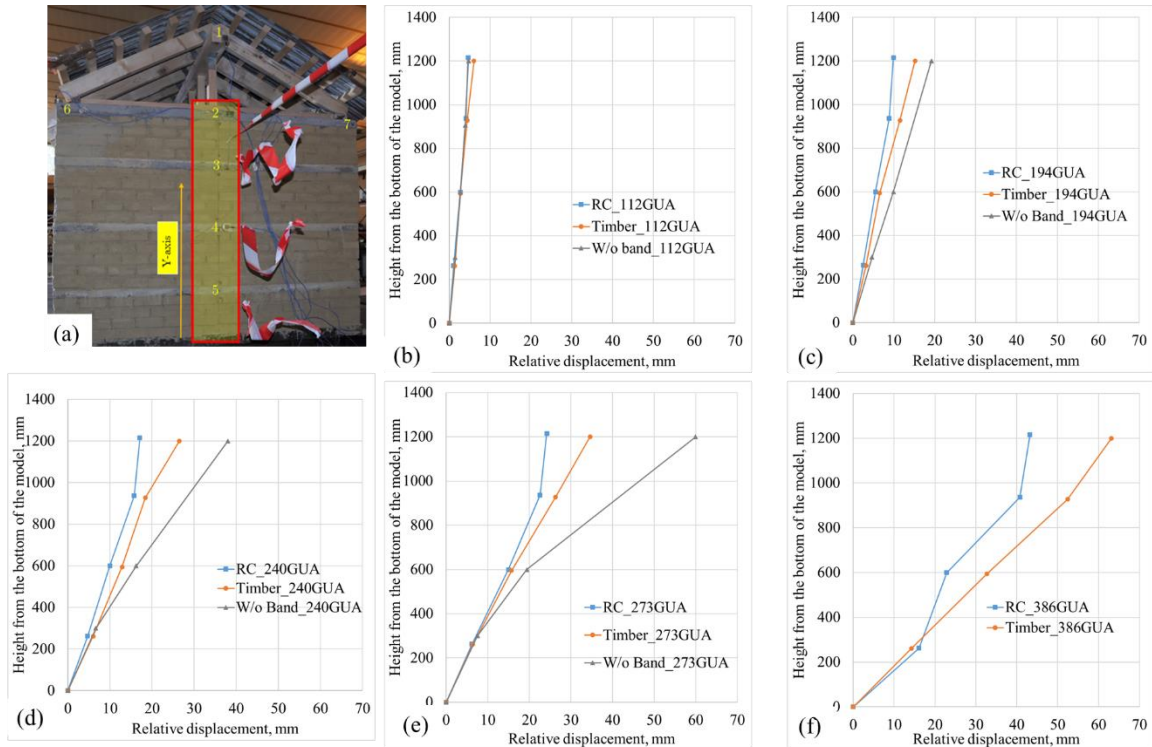
Out-of-plane (OOP) displacement is obtained from the DWDS placed at the band level on the OOP wall as shown in Fig. 24 (a). DWDS 2, 3, 4, and 5 recorded the absolute displacement of the OOP wall and the relative displacement was calculated by subtracting the table displacement. The maximum relative displacement occurred at DWDS 2, which is located at the free end of the wall. The maximum relative displacement at DWDS 2 was obtained for each house model and the corresponding relative displacement values at DWDS 3, 4, and 5 were extracted to compare the OOP displacement.

Fig. 24 (b-f) consists of a comparison of relative displacement of OOP wall under different loadings. The Y-axis in the graph represents the height from the bottom of the model, and X-axis gives the relative displacement value. A linear plot was used to interpolate the results between consecutive band levels, as DWDS were placed only at four band levels. At the 112GUA signal, all three models behave comparably, but past 194GUA signal, a significant difference in the OOP displacement pattern is noticed. The least maximum OOP displacement occurs in the house with an RC band, followed by the one with a timber band and then without a band house. The displacement at each band level is not following the same line slope as observed in Fig. 24(d-f) for 240GUA, 273GUA, and 386GUA signals, which results from the sliding at the interface between the band and the mortar joints. From these comparisons (Fig. 24), it is evident that the seismic bands help in reducing the maximum displacement of the OOP wall.

Fig. 24. Out-of-plane displacement along the mid-section of the wall at various loadings
