## **Shake table tests on 1:2 reduced scale masonry house with the application of horizontal seismic bands**

## **Abstract**

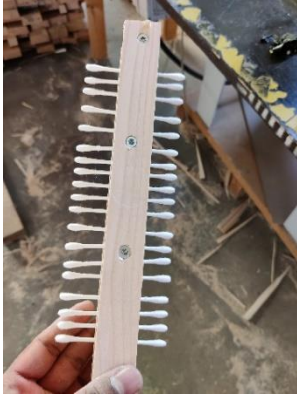
To prepare the wall surfaces, any loose particles were cleaned with a dry cloth, then two coats of white mat paint were applied to provide proper contrast. After drying for a couple of hours, an array of cotton buds was prepared, as shown in Fig. 7, and used to stamp black dots on the wall surface with mat black paint to avoid glossy reflections. This array expedited the process, and the black dots' density was later increased using single cotton buds. The grayscale image histogram for the speckle pattern surface had two peaks, as shown in Fig. 8, indicating even black and white distribution.

Fig. 7 Arrangement of cotton bud for application of black speckles pattern

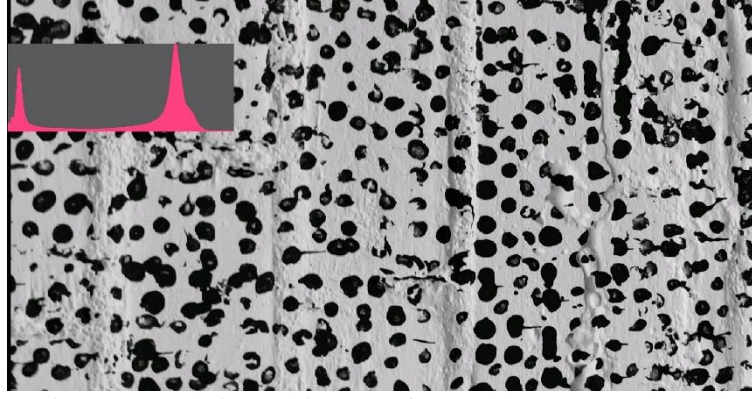
Fig. 8 Grayscale image histogram for speckle pattern on the wall surface

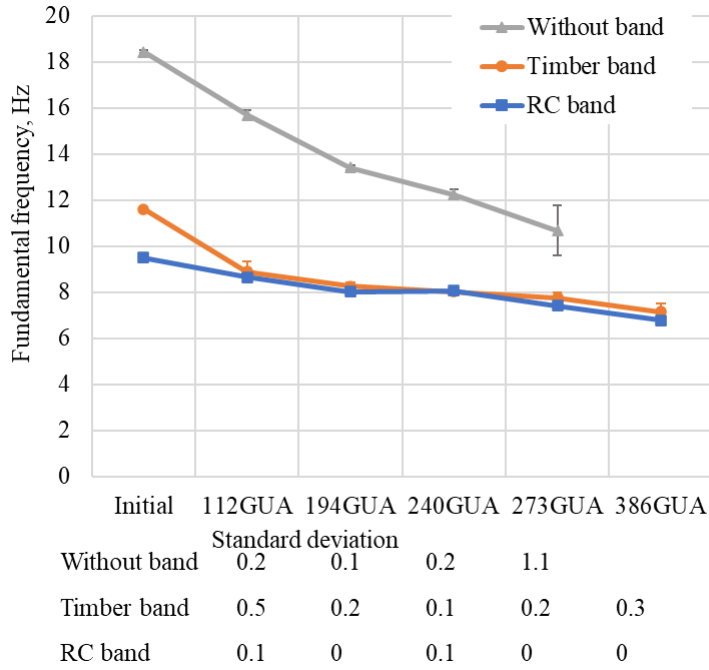
The fundamental frequency of structures is determined by analyzing the peaks in Frequency Response Function (FRF) obtained from the accelerometer data recorded during the application of a random white noise signal after each loading signal. The FRF results from the test exhibit a wavy pattern as white noise signal contain frequency ranging from 0.5 to 50 Hz. This makes it difficult to accurately identify the peak at resonating frequency. To overcome this challenge, standardization was necessary. The Gaussian curve fitting approach was used to standardize the FRF results. With the help of Gaussian curve fitting (MATLAB tool), a smooth curve was obtained from discrete FRF point results, which was finally used to identify the fundamental frequencies. The frequency corresponding to the peak response gives the fundamental frequency of the structures. The average results from the four BA<sub>1-4</sub> measuring along the loading direction are used to obtain the house model's fundamental frequency after each loading signal. The variation in the fundamental frequency for each of the three house model is shown in Fig. 13, along the error bars are indicating the standard deviation (SD). The high SD for the house without a band at 273GUA is due to the wide crack in the walls, resulting in differences in displacement and frequency. The fundamental frequency of structure varies with the application of a seismic band. The natural frequency for the house without a band is declining at a faster rate, whereas for the houses with a seismic band, the change is gradual, and the rate of degradation is comparable. For 386GUA loading (house without a band), all the measurement sensors were removed because of the risk of collapse and sensor damage.

Fig. 13. Variation in the fundamental frequency after each loading signal

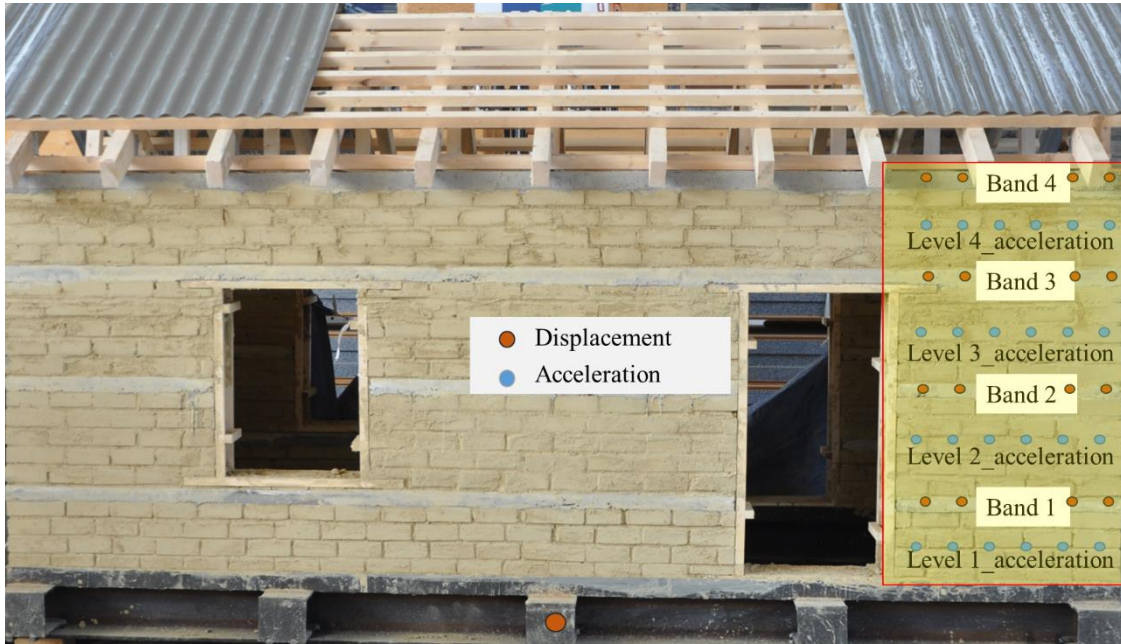
Fig. 18. Region selected for energy dissipation with a location represented for displacement and acceleration points
